Electric field mapping inside metallized film capacitors

61st Reliability and Maintainability Symposium (RAMS), 26-29 Jan. 2015, Palm Harbor

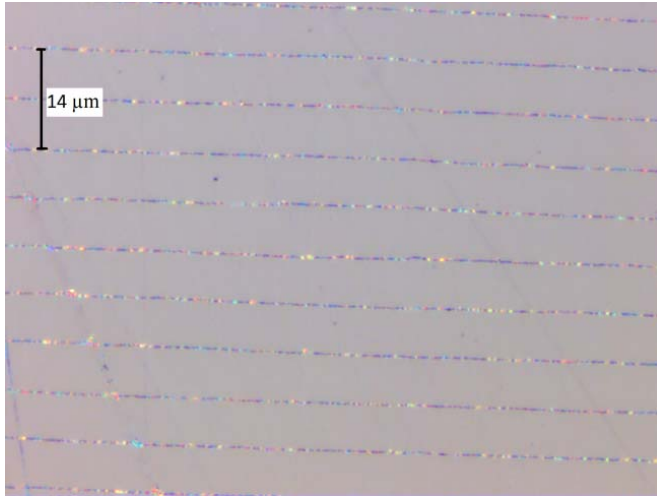
After the grinding procedure the quality of the grinded surface was inspected by optical microscopy. The requirements were low surface roughness, visible layer structure, and low concentration of grinding tracks. A microscopy image of a grinded capacitor surface is shown in figure 2, where it is seen that the requirements are fulfilled. The layer structure is clearly visible and there is only a few grinding tracks in the surface.

Figure 2: Optical microscope image at 1000X magnification of the micro-sectioned reference capacitor.

The surface roughness was further examined by AFM. From the measurements it was determined that the sample shown in figure 2 had an RMS surface roughness in the range of 20-30 nm, which also demonstrates the quality level of the grinding procedure.

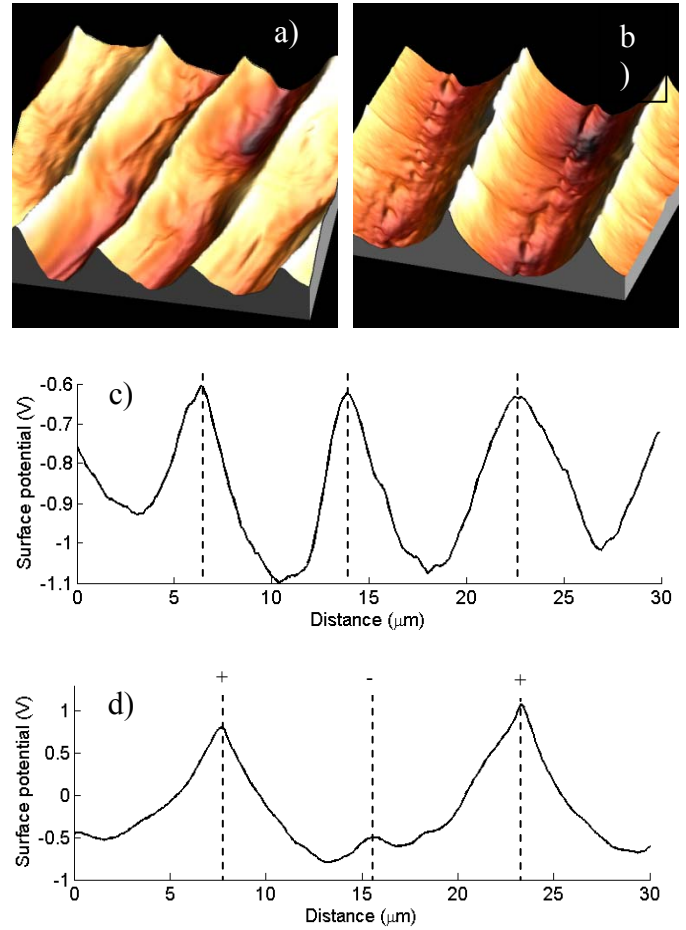
surface potential distribution. The results from the measurements without applied voltage and with 5V DC are shown in figure 3. The measured surface potential distribution on the capacitor with no applied voltage reveals a periodic surface potential profile despite the fact that no electric field should be present in the capacitor structure. This effect is associated with KPFM measurements on metal/dielectric heterostructures and arises due to polarization of the dielectric caused by the electric potential applied to the cantilever. The length of the period is around 7 μm , corresponding to the dielectric film thickness as shown in figure 2. The measured surface potential on the biased capacitor also reveals a periodic surface potential distribution. As expected, the period length is 14 μm , since every second metallization layer had 5V applied and those in between were grounded.

Figure 3: Results from the KPFM measurements on the unstressed film capacitor. a) Surface potential distribution of the capacitor, while grounded and b) while biased. c)-d) Cross-section profiles obtained from the surface potential measurements presented in panels a) and b), respectively. The dashed lines indicate the position of the metallization. The plus and minus signs indicate whether the metallization layers are connected to the biased or grounded end-spray, respectively.

The measured potential difference between alternating metallization layers does, however, not correspond to the 5V that was applied across the capacitor. There are multiple

The surface potential on the metallization sites, corresponding to the CPD between the cantilever and metallization, was measured on the grounded and biased capacitor to be -0.61V and -0.50V , respectively. This means that the metallization is not corroded on the reference capacitor. The magnitude of the CPD does not correspond to the expected CPD, which would be around -1V , according to table 1. This could also be explained by the point spread function of the cantilever, but also the fact that the work function varies with crystallinity and crystal direction in the surface [19]. It is also affected by the presence of a thin water adsorbate layer on the surface and possible contaminations from the surrounding environment, since the measurements were carried out in ambient air.
